## **Worn Out Power Packs Returned to Like-New Condition**

# Power Pool Plus: Re-Manufacturing

## The following example is of a recent Power Pack Re-Build

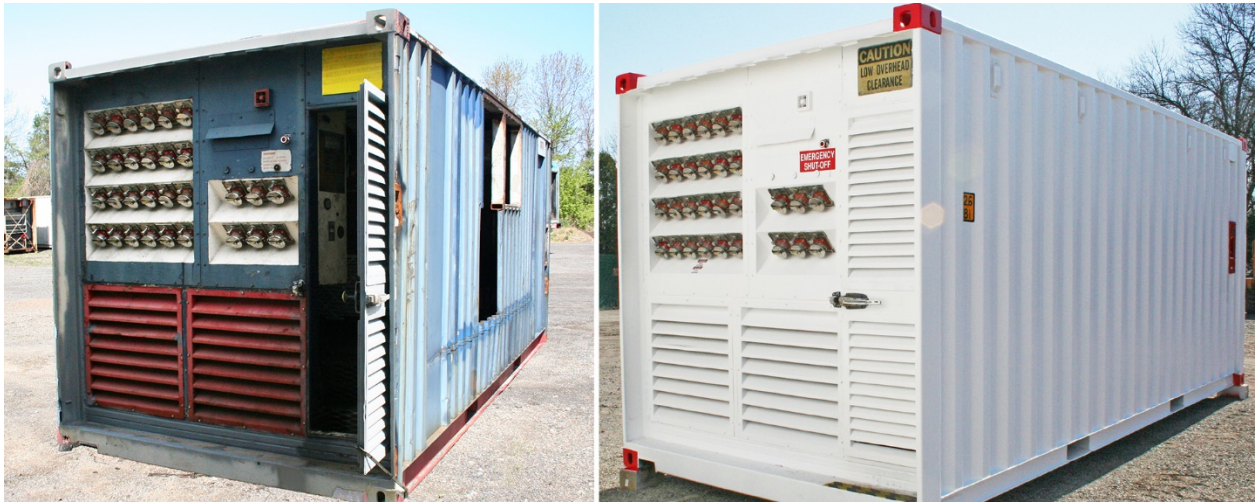
Our team has the ability to remanufacture tired, worn, or damaged power packs of any make or model. From blown engines and failed generators to damaged receptacle panels and crushed containers, we will work within your budget requirements to re-build your existing unit in order to save you both time and money.

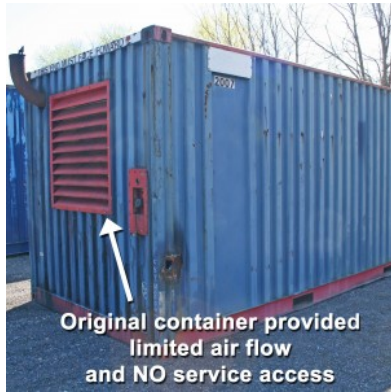
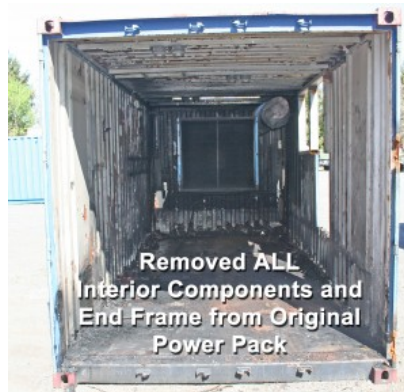
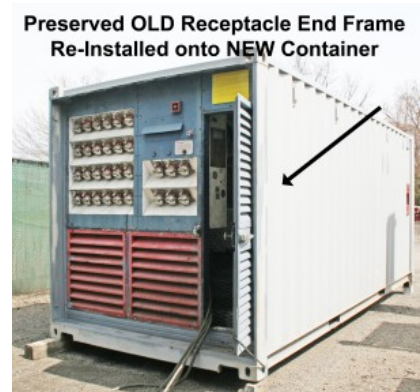
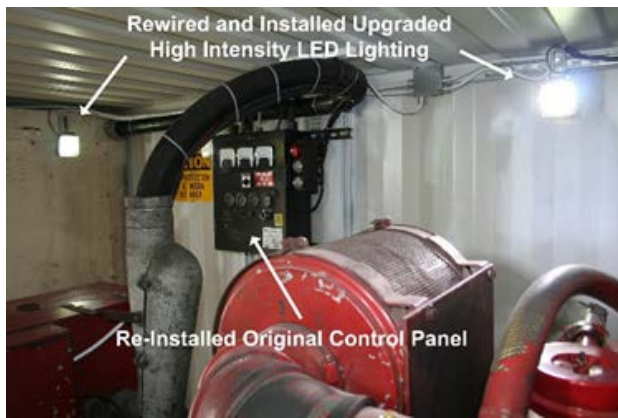
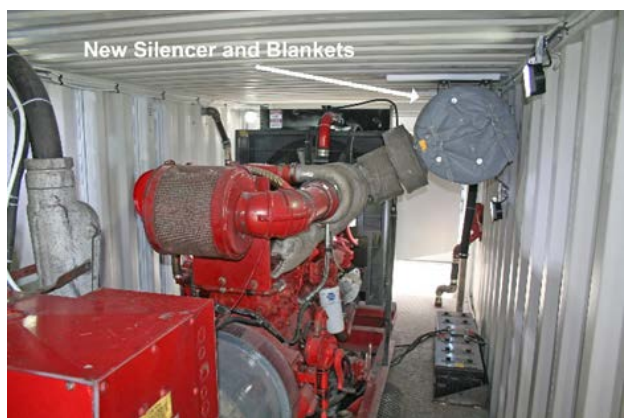
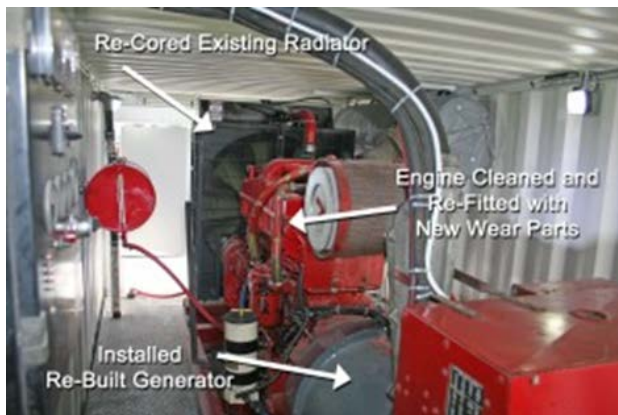
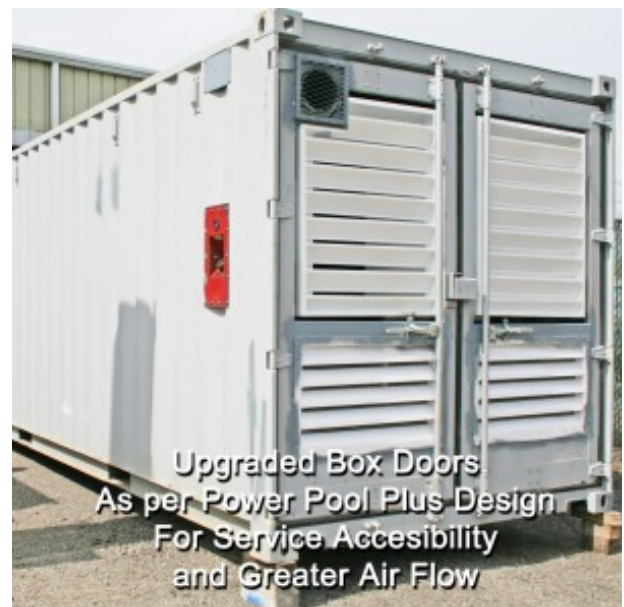
After being shipped to our facility for evaluation, it was discovered that this power pack needed generator replacement, the engine and radiator were leaking fluids, and the container itself was damaged.

- **Getting Started:** Complete removal of all interior components including end frame
- **Container:** New container was provided and fabricated to Power Pool Plus design specifications

- **Engine:** Overhauled in our shop with all new wear parts, cleaned and tested
- **Radiator:** Re-cored to provide better efficiency and cooling
  - *Re-coring is the process of re-fitting the inside coils with new components*

- **Generator:** Re-built and baked with new tropical coatings to protect the windings from excessive moisture
- **Fuel Tank:** Inspected for damage. Optional service, if necessary, to cut open for interior mechanical cleaning in the event of an excessive algae build-up scenario.

- **Lighting:** Increased number of fixtures and upgraded all lighting to high intensity, LED lamps. A critical feature to those that will be servicing the unit.

- **End Frame:** In this scenario we were able to save the end frame and integrated receptacle panel from the original unit for re-use. This helped us to save the customer \$1000's in replacement costs.

- Customer agreed to have us incorporate additional rain proof exhaust louvers and access doors per current Power Pool Plus design. This ensured easy accessibility for maintenance which will extend the service life of the machine.

- **Cosmetic Improvement:** Freshly painted both inside and out. It's not just about looking good.
  - Having a clean, freshly painted Power pack not only looks nice, but it ensures a solid base protection from the elements by mitigating the negative effects of rust and corrosion.

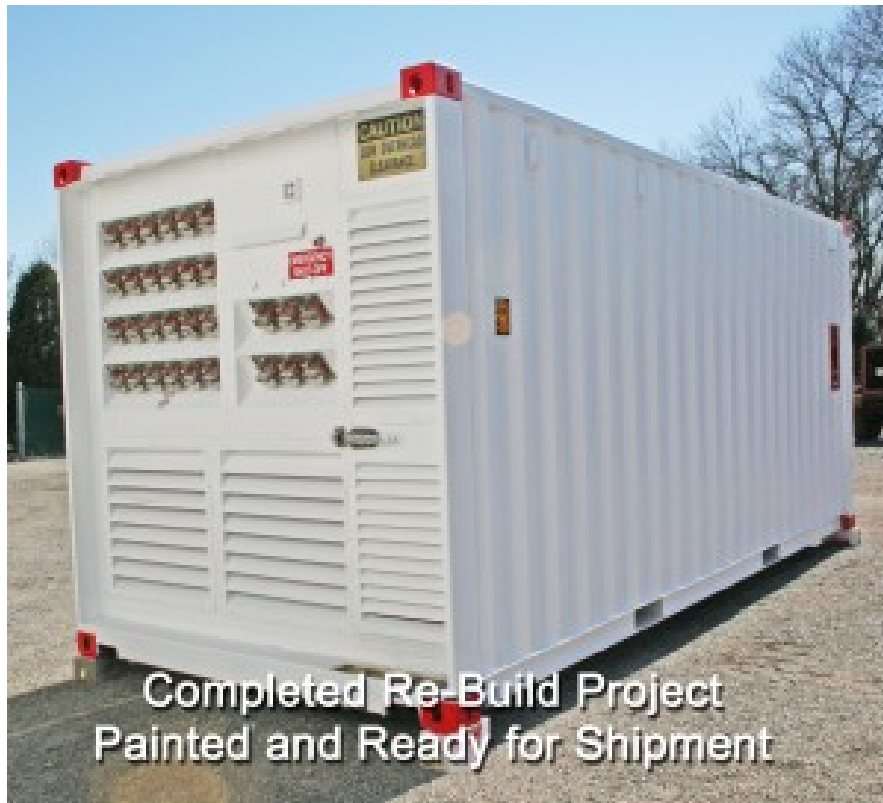
**This is just one example of the type of work that Power Pool Plus can do for your aged or damaged fleet of Power Packs.**
